# Investigation of Stair Accidents for Turkey

Chapter · October 2019

# INVESTIGATION OF STAIR ACCIDENTS FOR TURKEY

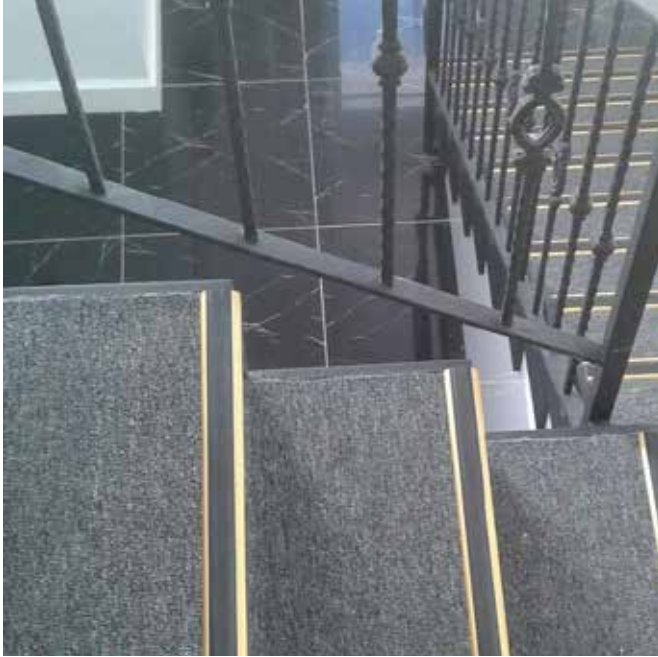
**Figure 10:** *An Example of Surface Cover and Stabilizer on Stairs That May Cause Accidents ("Stair Covering," 2017).*

The obstacles, objects on the stairs are a common reason of stair accidents. Another cause of accidents is surface of the stair. In some examples, stair surfaces are covered with carpet or similar materials to make stair look more elegant or to make stair slip resistant as can be seen in Figure 10. Nemire et al. put emphasis on slip resistance to lower the accident rates. The risk seen when the cover material or the stabilizer become loose. This situation may lead users to slip, stumble, and trip over the stair.
