Evaluation on Accessibility in Historical Environments in Turkey: Ankara Ulus Environment Example

I. TBMM/ War of Independence Museum Accessibility Assessment

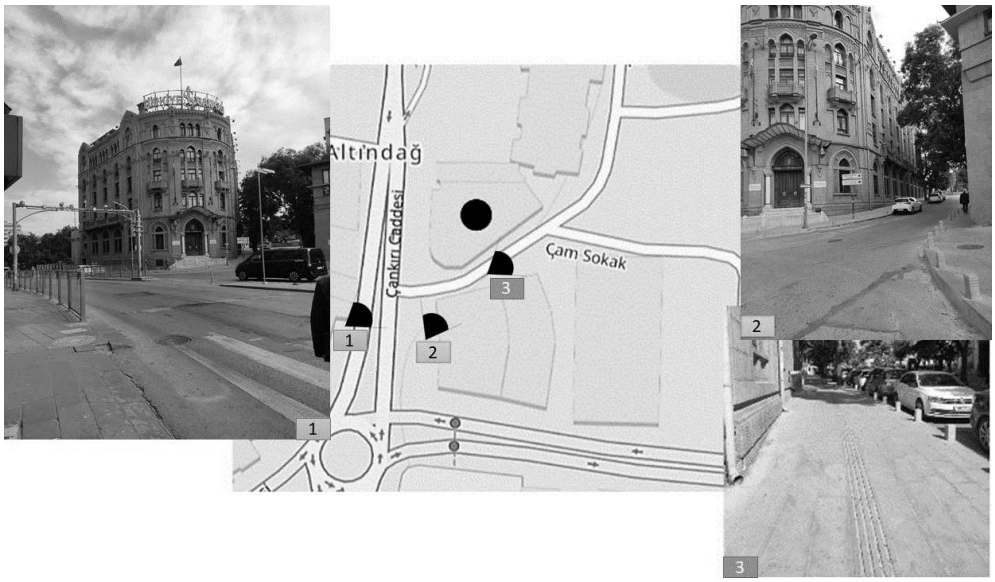
Figure 13. Is Bank Museum and Its Surroundings

Problem: Ramps have been added to the sidewalks corresponding to the building entrance. Ramps are included in the standards; It was applied as a ramp inclined in three directions. However, there is an application error since a rainwater channel was added. The pavement has a guide and warning surfaces, but the warning surface needs to be placed correctly. In addition, the stimulating and guiding surfaces should be contrasting to the ground color and be noticeable. Currently, it is applied in the same color as the pavement.

Problem: There are no warning surfaces in front of the stairs. There is no handrail (Figure 15).

Suggestions: A portable ramp can be added to the building entrance when necessary. The water channel in front of the sidewalk ramp should be removed. Guide and warning surface colors should be changed.
